MECHANICAL ENGINEERING NOTE 377

R.A.N. SEA KING CABIN ENVIRONMENT SURVEY

Part 2.

MEASUREMENT OF TEMPERATURE AND HUMIDITY

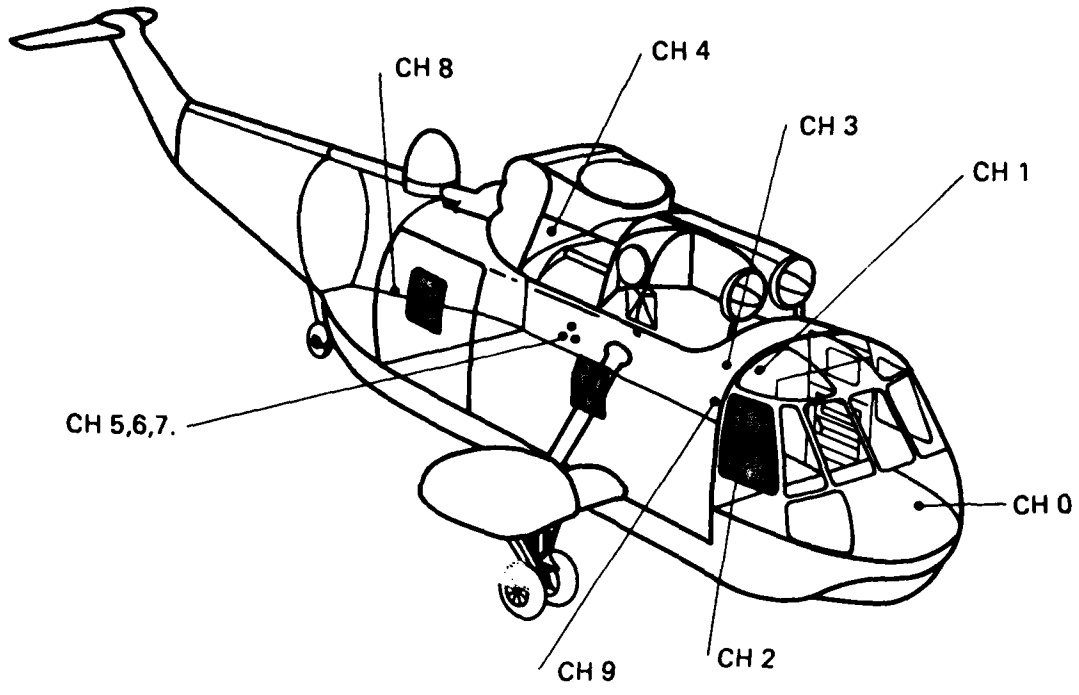
FIG. 1: LOCATION OF TEMPERATURE SENSORS

CHANNEL	PARAMETER	LOCATION
0	Air temperature	Co-pilots feet area
1	Black globe temperature	Cockpit
2	Air temperature	Rear of pilot's seat, at chest height
3	Air temperature	Forward cabin
4	Skin temperature	Roof of aft cabin
5	Dry bulb temperature	Between sonar/navigator crew
6	Black globe temperature	Between sonar/navigator crew
7	Wet bulb temperature	Between sonar/navigator crew
8	Air temperature	Aft compartment
9	Outside air temperature	Cabin fresh air intake grill

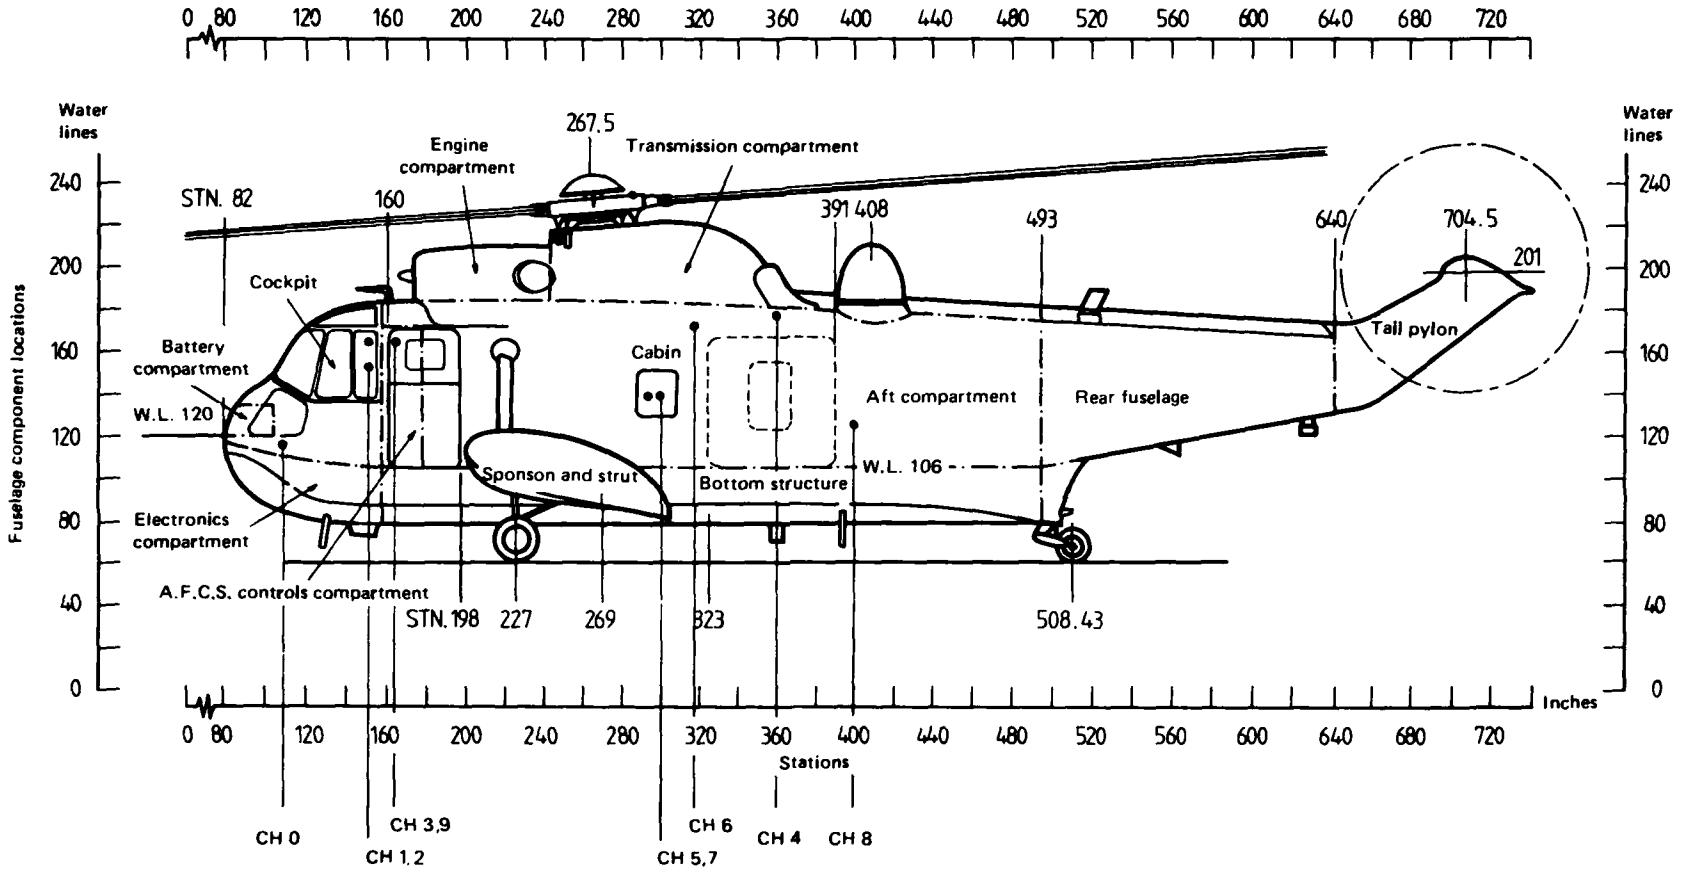
FIG. 2: LOCATION OF TEMPERATURE SENSORS AT VARIOUS AIRCRAFT STATIONS

The skin temperature was measured by attaching a thermocouple to the inside of the skin, in the location shown in Figures 1 and 2. From Appendix 1, the highest recorded temperature

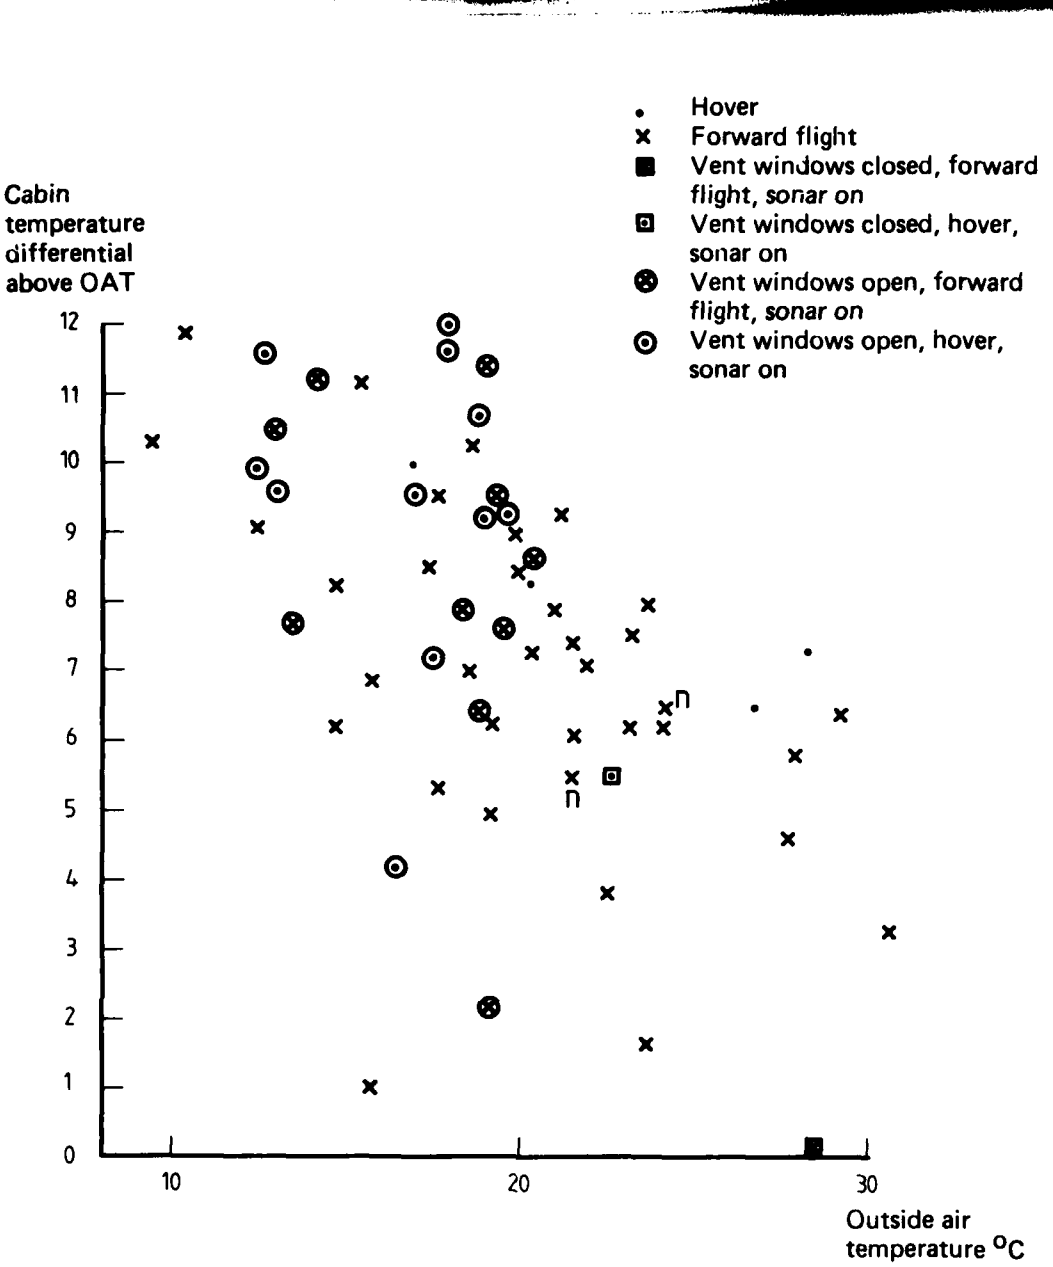
FIG. 3: CABIN TEMPERATURE RISE ABOVE OUTSIDE AMBIENT TEMPERATURE

In Figure 3 the rise in cabin dry bulb temperature (sonar/navigator crew position) above ambient temperature is plotted *vs.* ambient temperature for all of the records in Appendix 1. This figure shows a wide spread of results with the only discernible trend being an apparent decrease in temperature differential with rising outside air temperature.

Laing *et al.* (1975) carried out a survey of temperatures in 20 different locations in the CH-47 helicopter; the average temperature rise in the cockpit was 6·5°C (forward flight) and 5·1°C (hover), in full solar radiation. These temperatures are similar to those found for the RAN Sea King (see Fig. 3).
